**Acle Nursery
Fletcher Room
Fletcher Way
Acle**

Structural Inspection Report

Document No:	Issue Date:	Issued to:			Format Issued			
					Email	Disk	Digital upload	Post
NS23/046	09/01/2024	Acle Parish Council			✓	<input type="checkbox"/>	<input type="checkbox"/>	<input type="checkbox"/>
Document Revision No:	Issue Date:	Document Revision Comments	Revised by (INT):	Reviewed by (INT):				
Job no/report/RevA	Click or tap to enter a date.				<input type="checkbox"/>	<input type="checkbox"/>	<input type="checkbox"/>	<input type="checkbox"/>
	Click or tap to enter a date.				<input type="checkbox"/>	<input type="checkbox"/>	<input type="checkbox"/>	<input type="checkbox"/>
	Click or tap to enter a date.				<input type="checkbox"/>	<input type="checkbox"/>	<input type="checkbox"/>	<input type="checkbox"/>

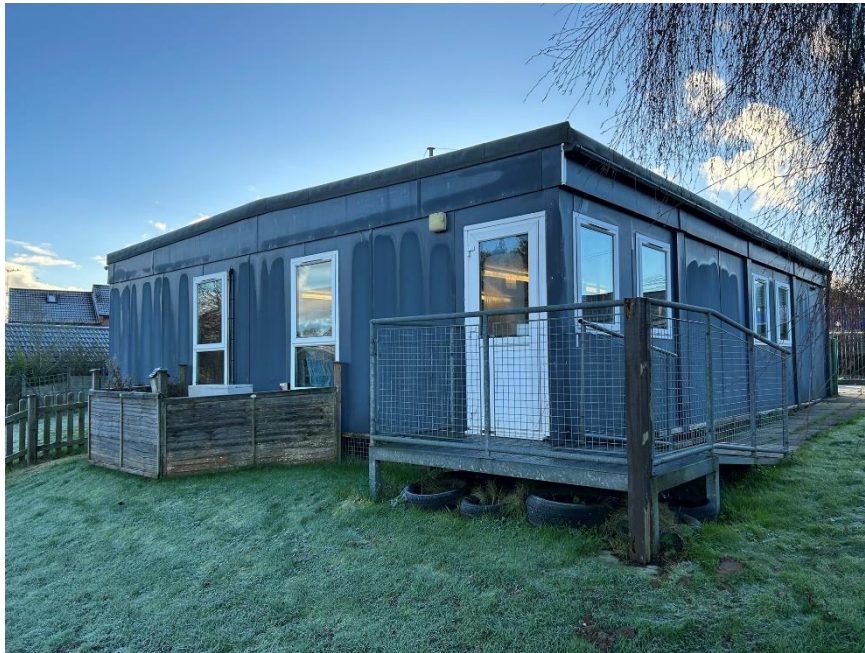
- 3.2 Photograph 1 shows a general view of the north and west elevations of the building where the junctions between each modular element is expressed externally with a cover strip to the western wall. The site generally falls to the playing fields to the north and the ground has been banked up to the extent of the building.

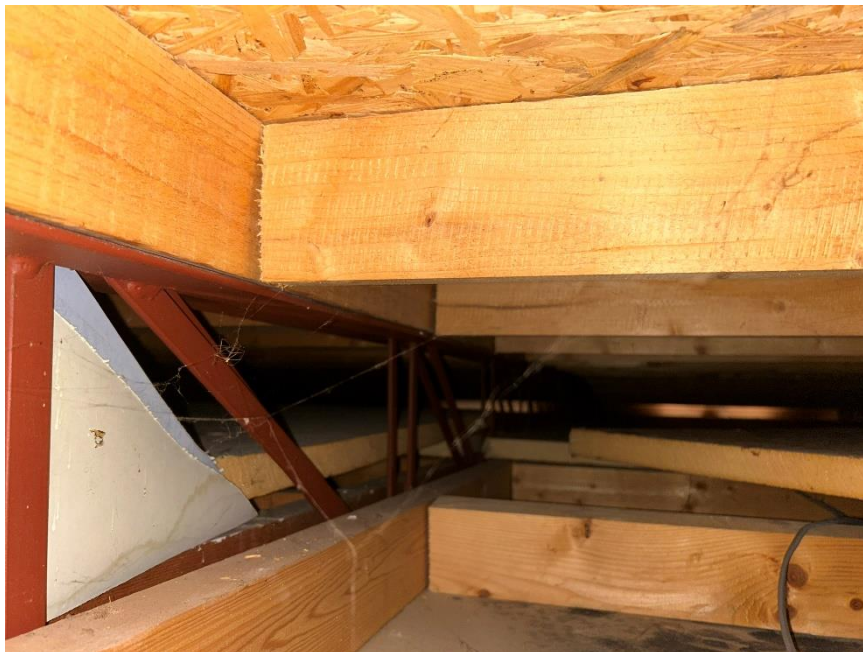
- 4.2 Access to the roof construction was limited to small hatches along the western elevation, but from within the hatch closest to the damaged ceiling area, the roof construction was visible.
- 4.3 Photograph 2 shows a general view from the hatch position. The primary support across the width of the building is a pair of lightweight steel truss sections formed from flat plate, assumed to be one to the edge of each module.
- 4.4 Both roof and ceiling structure are supported on the trusses, via timber plates supported on the truss flanges. Both roof and ceiling timbers measured approximately 45mm x 97mm deep.

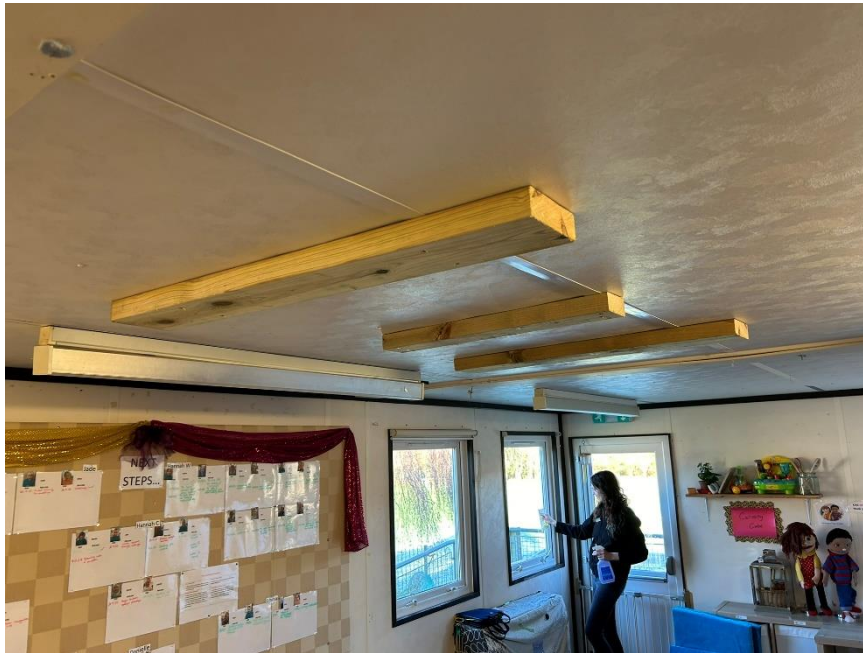
Photograph 3

- 4.5 There was no significant visible sagging to the roof or ceiling joists and as such, it was concluded that the issue with the sagging ceiling beneath related to inadequate fixings of the plastic-coated ceiling panelling between supports.
- 4.6 This was very crudely rectified on site by Ovamill's operative, by connecting a series of timber battens up to the ceiling joists and sandwiching the sagging ceiling between the batten and ceiling joist. (See photograph 3).
- 4.7 If the building is to remain in situ you may wish to seek a more permanent solution, which would be replacement of the ceiling panelling and improved fixings up into the ceiling joists above. The current ceiling panel cannot be reused as this has become brittle and has been damaged slightly by the repair.

- 6.1 As per correspondence issued to you immediately after our inspection, we do not consider that there is a significant structural fault with the roof or ceiling construction, and the sagging ceiling was attributable to inadequate fixings into the plastic-coated ceiling board which has sagged over time. This was addressed by Ovamill's contractor during our inspection by fixing up battens to the underside of the ceiling screwed into the timber joists above. We have undertaken a basic check on screw capacities and were satisfied that the embedment into the ceiling joists is sufficient to hold the ceiling in situ.

- 6.2 If the building is to remain in situ over a longer period you may wish to seek a more permanent and aesthetically pleasing repair, which should incorporate a new ceiling panel and more frequent fixings up to the existing ceiling structure.

- 6.3 It is possible that other ceiling panels are also poorly connected to the structure over and it may be prudent to have a contractor attend and address this to mitigate the need for reactive works should a similar defect become apparent at a later date.

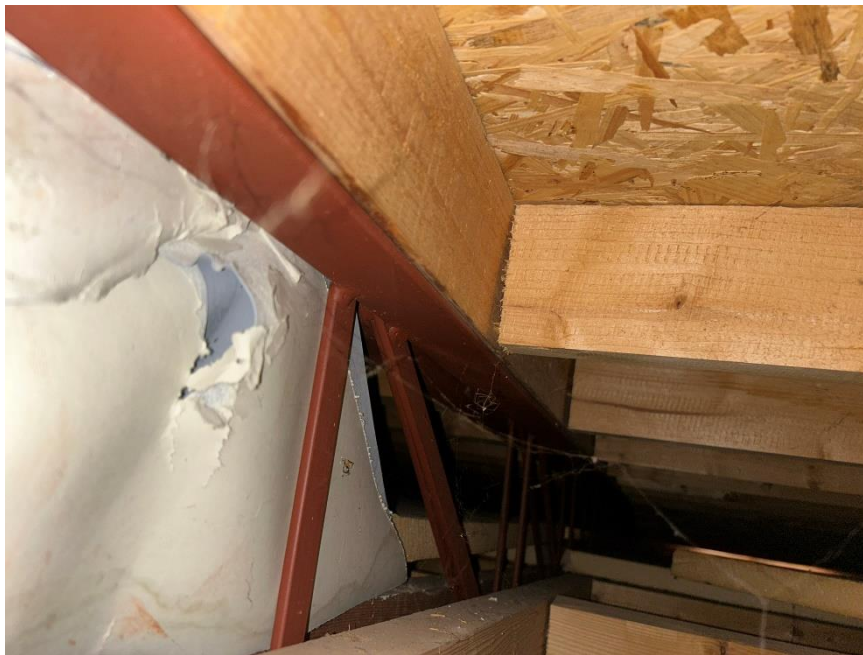
- 4.8 In terms of the roof construction, whilst significant deflections were not apparent in the structural elements, some gaps were noted between the ceiling joists and edge member they are connected to. Photograph 4 shows a series of gaps between the roof joists and the edge timber.
- 4.9 The timber fixings were not visible from our vantage point at the loft hatch, but it is assumed that the joints are either skew nails fixed from the opposite side or fixed into the end grain of the roof joists from the far side of the edge timber. For permanent construction we would typically expect to see either the joists run onto the bearing or a proper joist hanger at the connection. Although these appear to have performed adequately to date, these connections do not appear to be particularly robust.

- 6.4 In terms of the building's longevity, we do recognise that it is obviously a temporary structure, which we understand was constructed in 2000 / 2001. We have only been able to inspect limited areas of the building from small loft hatches and below the welded mesh skirt. In those areas however, the structural timber appears to be in reasonably good condition and whilst the roof level connections, between the common joists and the edge members supported on the trusses does not appear to be particularly robust, it is evidently performing adequately currently.

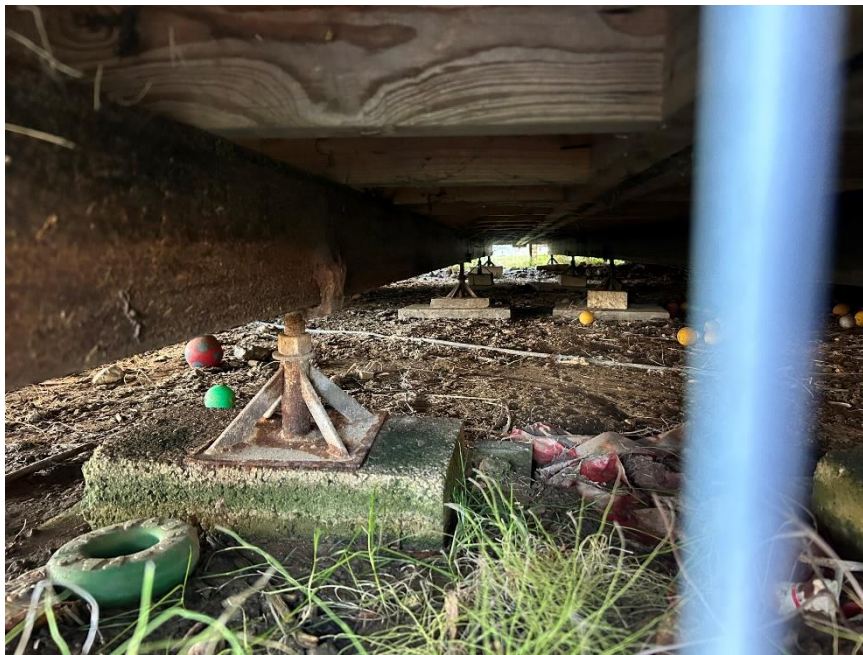
- 4.11 A limited inspection of the ground floor construction was possible externally by looking through the steel mesh skirt around the perimeter of the building. Photograph 5 shows a general view of one of the steel skids supporting the floor joists.

- 4.12 The skids are set slightly in from the edges of the module with the joists cantilevering past to an edge timber. The joists are of adequate dimension to accommodate the modest cantilever, and as such any gap between the main modules is more likely to be attributable to minor movements between each module due to ground movement rather than inadequacy of the structural fabric.

- 4.13 Also evident in photograph 5 is the support to the steel skids, which comprises a series of adjustable feet onto pad, possibly block foundations. The extent of the foundation was not exposed as part of our inspection but is unlikely to be substantial for this lightweight temporary structure. Also of note is that the general topography of the site slopes down towards the north end of the playing field beyond. The ground has been banked up below the building so it is possible that the north end foundations have been taken onto made ground only. This may be leading to differential

settlement and potentially the gap between the north and north central modules of the building, as noted by nursery staff.

- 6.5 In respect of the gap between the north and north central bays and the slope to the floor construction in the north bay, we consider that this is likely attributable to inadequate foundations, potentially into made ground. At present this is not significantly affecting the building's use and because of the building fabric, significant cracking is not evident either internally or externally, as would likely have manifested with a masonry building. We cannot rule out the possibility that further movement occurs at this end of the building, particularly in light of the unknown nature of the foundations and subsoils.
